*hp AlphaServer GS1280/ES80/ES47  
V7.3a Console Firmware Release Notes*

*This document contains firmware enhancements and update  
procedures. Start with Read Me First.*

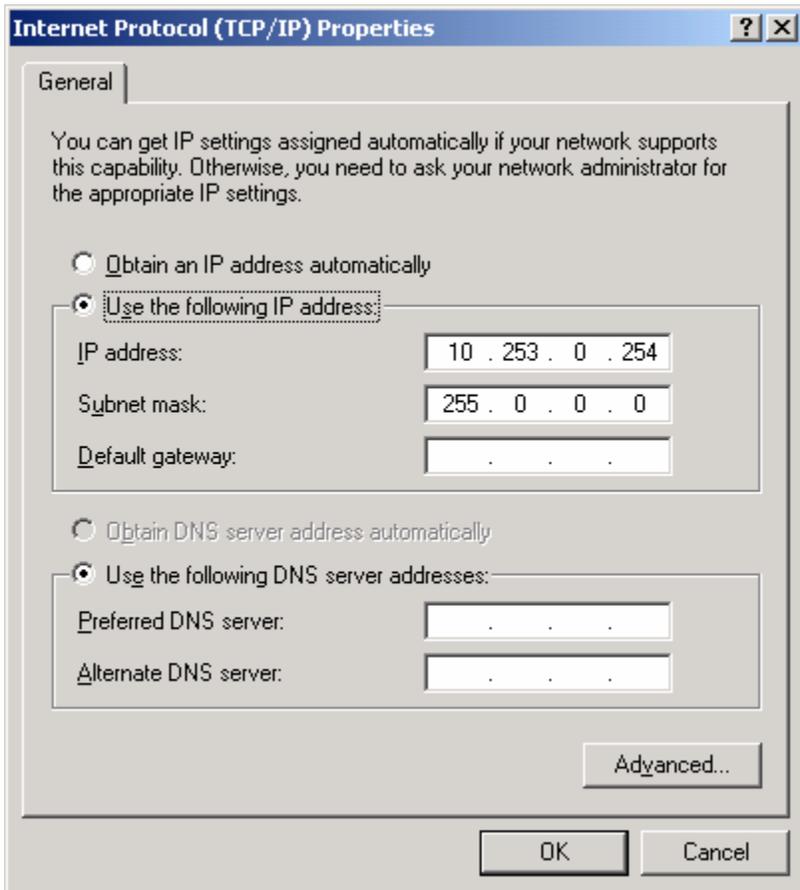
The remainder of this document has examples using the static address “10.253.0.254”.

If using DHCP, check *Obtain an IP Address automatically*.

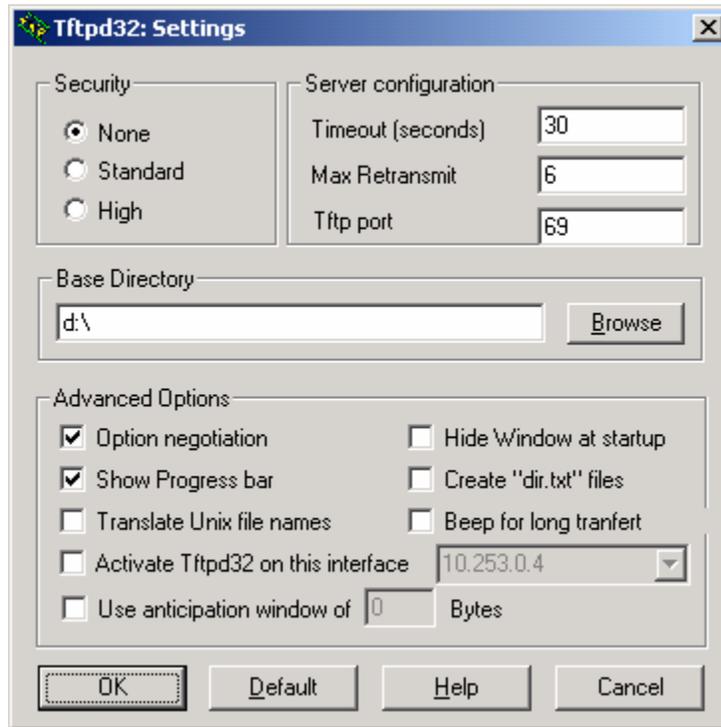
Start the TFTP Server on the PC by invoking `tftpd32.exe`. A copy of `tftpd` can be downloaded from <ftp://ftp.hp.com/pub/alphaserver/firmware/other/utility/>. Download and unzip the file to a convenient directory on your local PC. Then change the settings to point the directory containing the files to be upgraded.

Click OK.
